PROFESSIONAL HOME INSPECTION REPORT

Concerning: property address
(Address or Other Identification of Inspected Property)

By: RAUL CARRILLO MONTANO 20404 5/19/2020
(Name and License Number of Inspector) (Date)

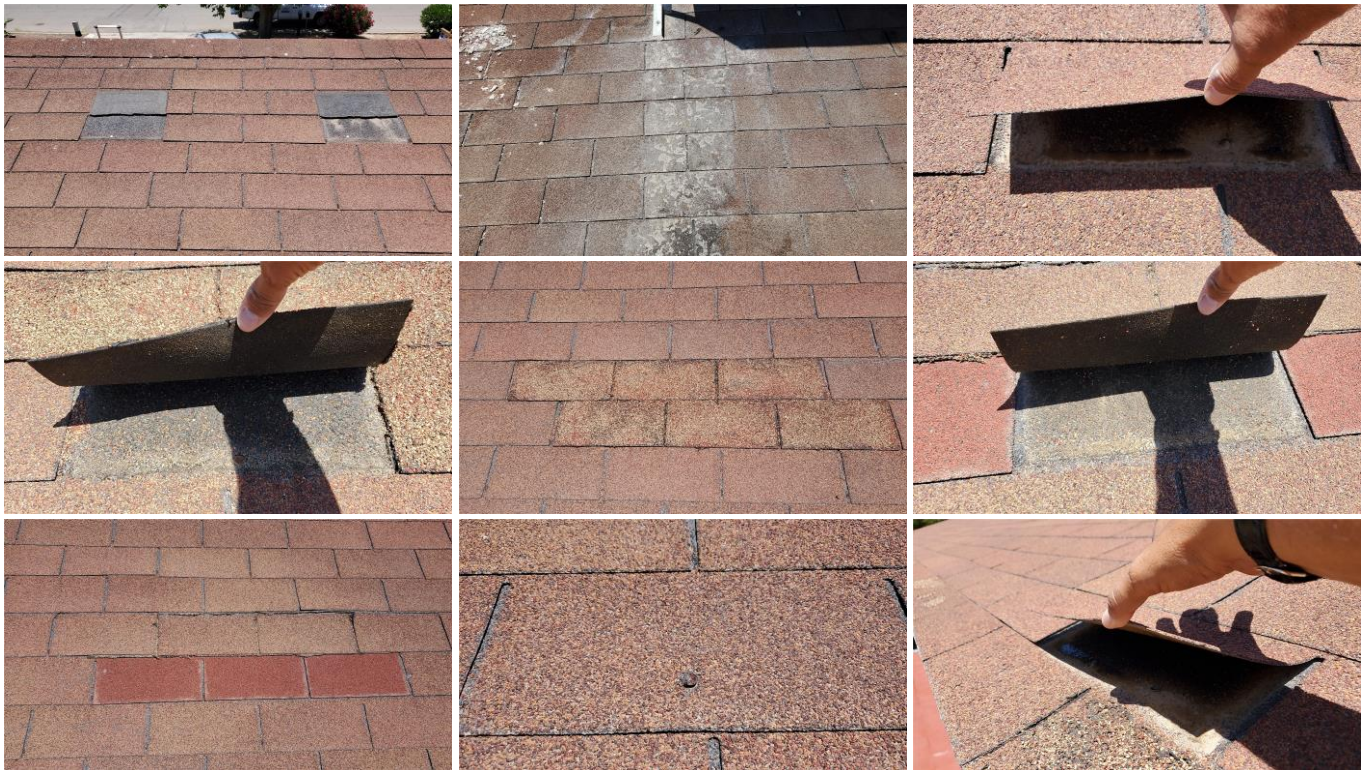
1. There were several shingles broken, missing, detached, and / or lifted due to lower wind resistance. Shingles may become detached and blow completely off from the roof. This type of failure is often caused by poor bonding of the adhesive strips, resulting in tab-uplift forces that break the bonds completely. The wind can then lift the tab and enter beneath the affected shingle, increasing the uplift forces on that entire shingle.

2. There were some nails exposed that should be removed or sealed to avoid water penetration. Exposed nails will corrode over time, and expansion and contraction may eventually expand the nail holes enough to allow leakage. Shingle manufacturers recommend replacing any shingles with exposed fasteners. They consider caulking nail heads to be a temporary repair.

3. **Evidence of replaced shingles.** - A patch is not always a problem, but it usually indicates a previous leak or damage. Patches warrant a close look to determine there is a proper tie in with surrounding shingles. If surrounding shingles are old and brittle, a good tie in is hard to accomplish.

4. The shingles below the cooling equipment appeared to be noticeably worn. Water draining or leaking from a rooftop mounted evaporative cooler can cause hard water calcium stains on asphalt shingle roofs. Sometimes they can be only white stains on the surface, which do not cause any damage to the shingles. But other times these calcium stains can hide some shingles damages.

- **CORRECTION NEEDED AND FURTHER EVALUATION RECOMMENDED:** Contact a qualified roofing contractor for further evaluation and repair / replacement as needed.

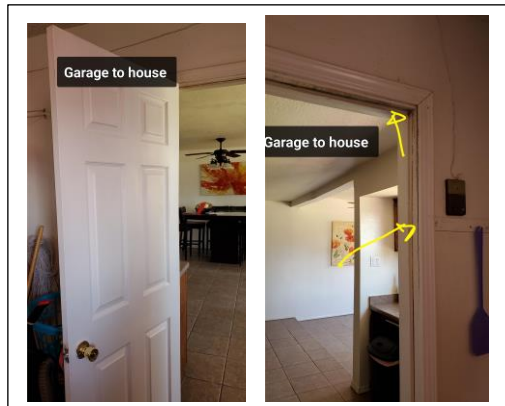
- Should be fire rated. The door may be a solid-core wood not less than 1-3/8" (35 mm) in thickness, solid or honeycomb core steel doors not less than 1-3/8" (35 mm) thick, or 20-minute fire-rated doors.
- Weather strip deteriorated in garage access door: The door between the garage and the interior of the house should be well sealed to prevent automobile fumes from entering the house.

Recommend correction to ALL defective interior & exterior doors as to allow proper safety and function.

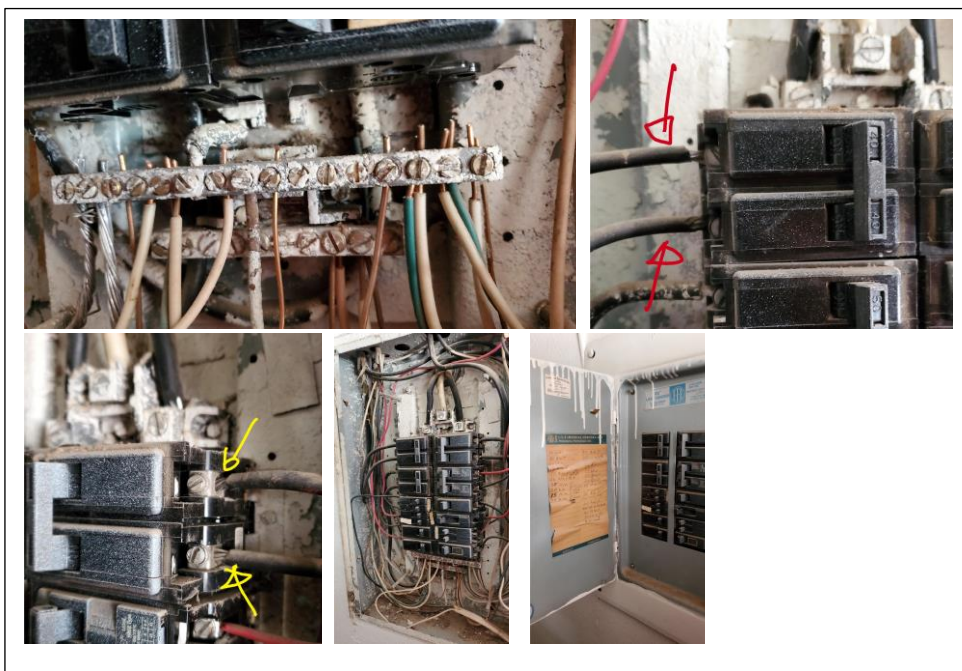
1. The electrical panel lacks main circuit breakers. This panel needs more than 6 movements to turn off the power of all the house and this is a deficient. This is a safety hazard because the NEC requires no more than 6 switches and must be close enough together for all to be operated with no more than 6 hand movements.

2. Double tapped neutral wires were observed in the service panel. One neutral wire per screw set is the recommended installation requirement.
3. The service panel is NOT completely and/or properly labeled. All breakers must be specifically identified as to appliances, lighting and receptacles. *Checking each breaker to see if each one was identified correctly is beyond the scope of the inspection, this evaluation should be conducted by a professional electrician.*

4. The aluminum wire connections did not show anti-oxidant compound. Without it, aluminum wiring will oxidize, and aluminum oxide is a good insulator. Therefore, oxidation will cause a poor connection and become overheated, perhaps enough to cause a fire.

Correction needed and further evaluation by professional electrician.

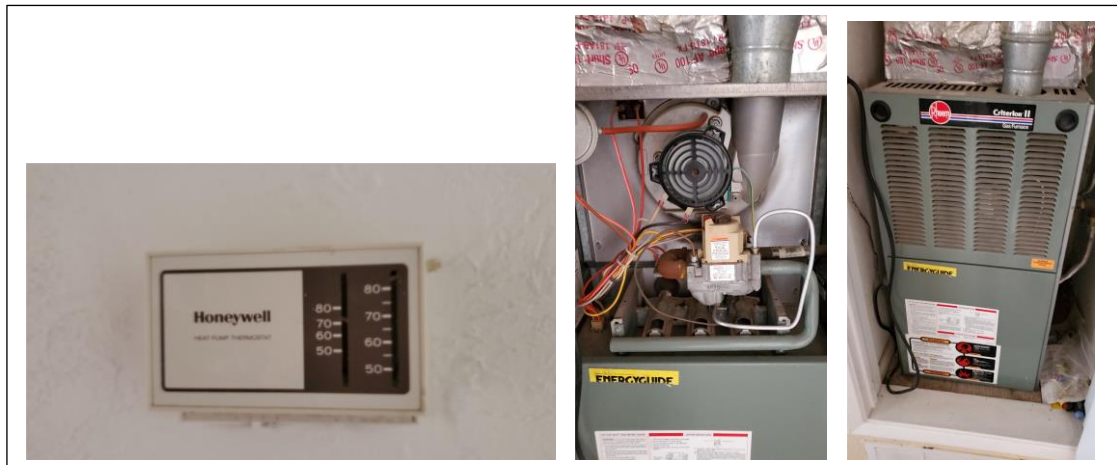
Furnace not reaching set temperature

Recommend correction and reinspection prior to close of escrow or evaluation by a licensed HVAC contractor.

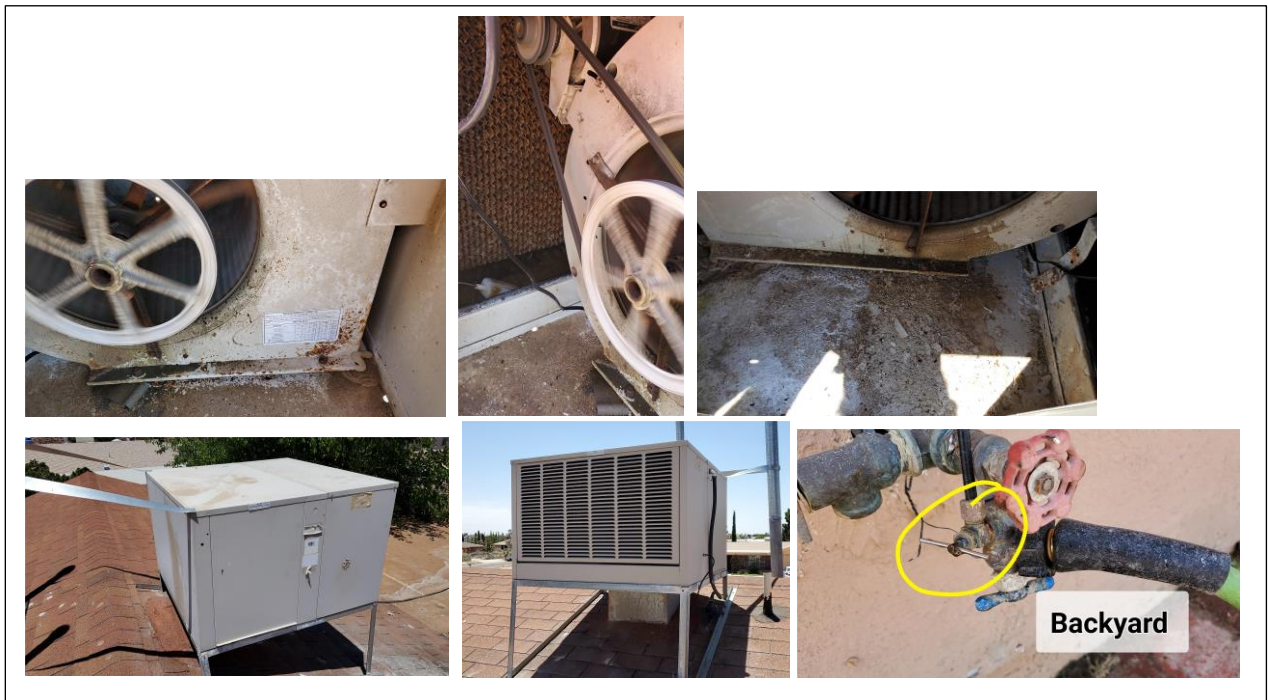
1. The enclosure needs to be cleaned.
2. The water shutoff valve was leaking.
3. Rust or corrosion spots were noted on the enclosure.

The corrosion of steel enclosures results from exposure to oxygen and moisture. Corrosion is accelerated in the presence of salt from roadway deicing, salt water or perhaps salts deposited from other sources. There are methods for preventing corrosion of structural steel. Refer proper maintenance with a qualified technician in HVAC in a short time, the corrosion can cause water leaks.

Corrections needed in order to prevent further damage, proper maintenance and regular inspection is necessary.

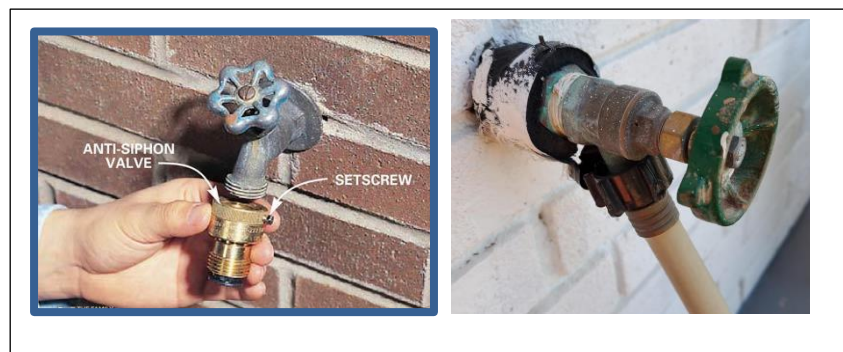
1. One or more of the exterior water hose bibbs {faucets} was not equipped with a back flow and/or anti-siphon {vacuum breaker} device. An anti-siphon device prevents unsanitary water from being pulled back through a garden hose and/or lawn sprinklers and contaminating the household water system.

Corrections needed.

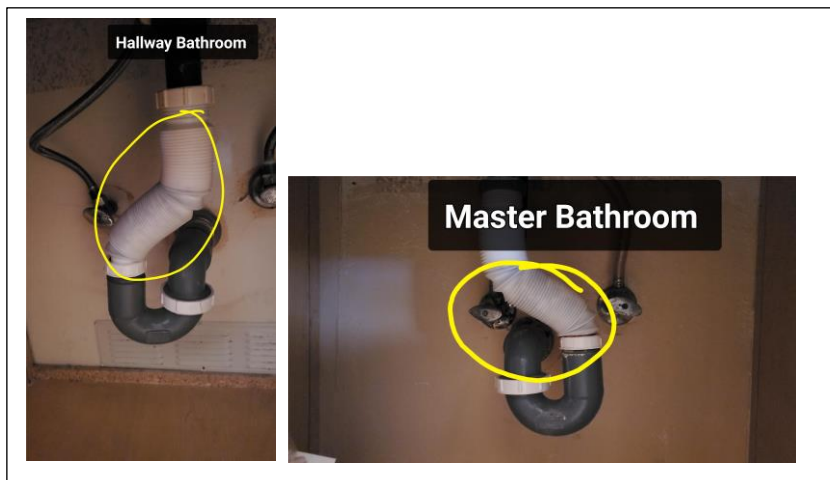
1. Bathrooms sinks with a corrugated piece of pipe that is no approved. Between the fixture and the trap is the tailpiece. This pipe should be smooth-walled material that is compatible with the trap material. The flexible, ribbed material available at big-box retailers isn't allowed because the ribs hold unsanitary materials, and this material is prone to clogging. The vertical distance between the fixture and the trap should be less than 24 inches. This helps prevent stuff from building enough force to blow out the trap's water seal. "2009 IRC P3002.1 Piping within buildings. Drain, waste and vent (DWV) piping in buildings shall be as shown in Tables P3002.1(1) and P3002.1(2) except that galvanized wrought iron or galvanized steel pipe shall not be used underground and shall be maintained not less than 6 inches (152 mm) above ground. Allowance shall be made for the thermal expansion and contraction of plastic piping."

- **Correction needed.**

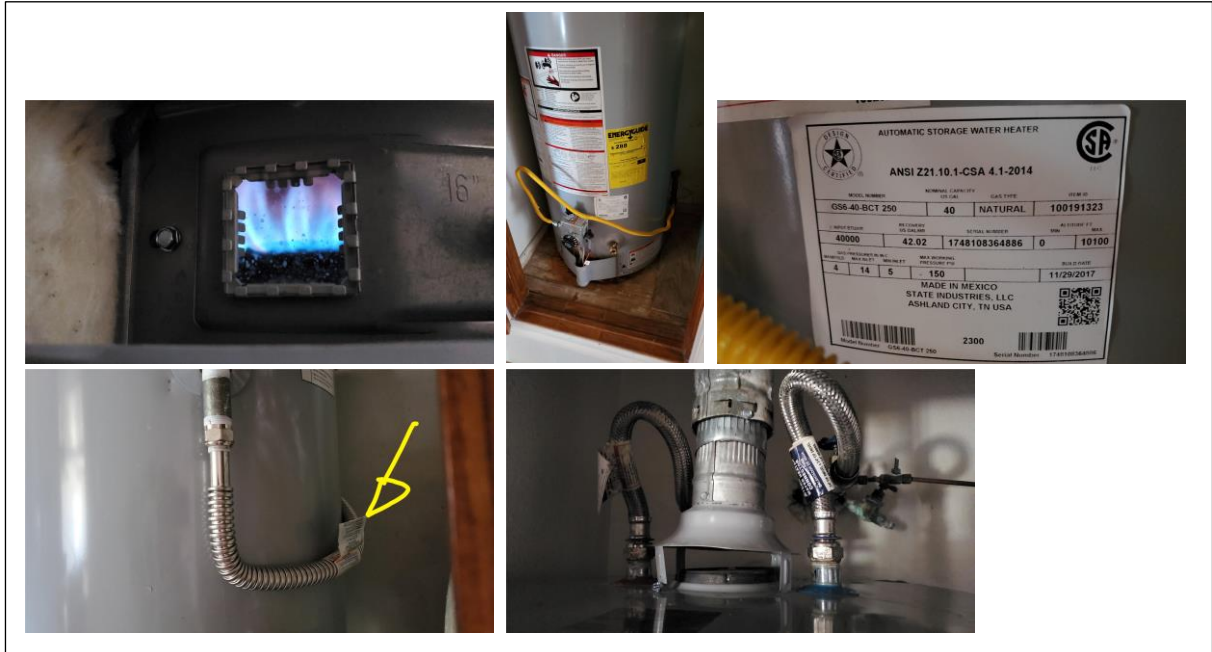
3. A drainpipe was missing. The pan drain should be terminated in indirect waste or outdoor 6-24" above grade. Recommend its installation.
4. There was not sediment trap on water heater gas pipe. Sediment traps are intentionally installed to help prevent sediment in the gas piping from getting into the gas valve or burner area of an appliance and fouling things up.

Corrections needed.

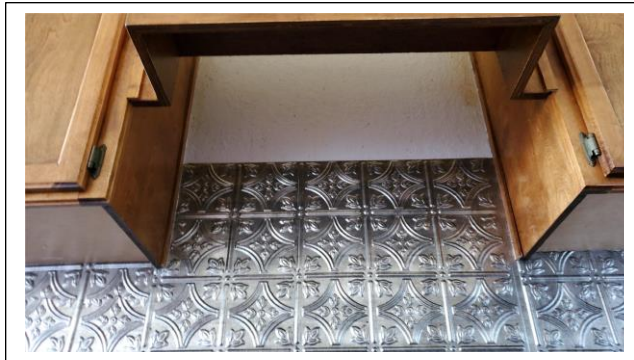
1. There was no range hood. Most residential building codes do not require a range hood above a stove or cooktop, but it is important to ensure its locale is not the exception. The range hoods are designed to collect airborne grease, toxins, moisture, and cooking odors. **Deficient.**

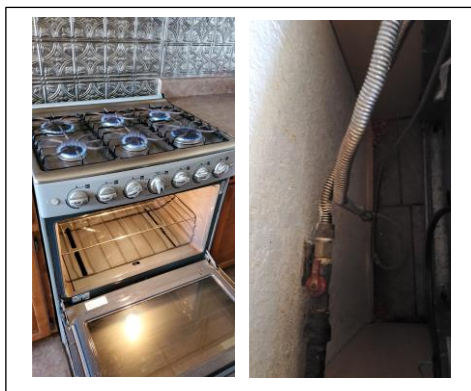
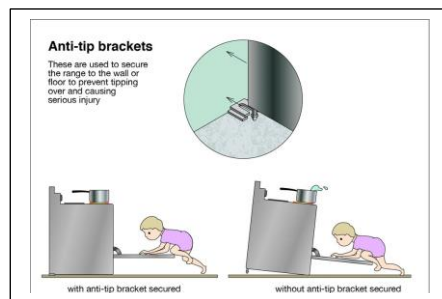
- Stove and oven operated normally.
1. Anti-tip bracket is missing from range installation (to anchors it safely to the floor or the wall). All free-standing, slide-in ranges include an anti-tip device and is essential in the safe operation of the range. It provides protection when excess force or weight is applied to an open oven door. Anti-Tip devices became a UL (Underwriters Laboratories) safety standard requirement in 1991. This is a safety issue as the oven could potentially tip over if a child were to stand on the door.
- **Correction needed.**

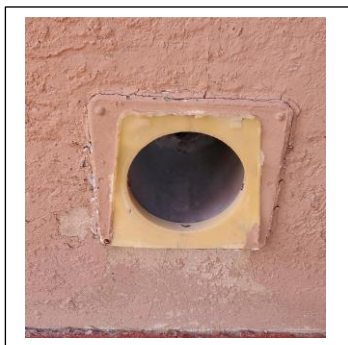
1. There was no dryer exhaust hook. The duct termination should be fitted with a closeable gravity or automatic damper (a backdraft damper).

- Correction needed.
