PROFESSIONAL HOME INSPECTION REPORT

Concerning: property address
(Address or Other Identification of Inspected Property)

By: RAUL CARRILLO MONTANO 20404 5/19/2020
(Name and License Number of Inspector) (Date)

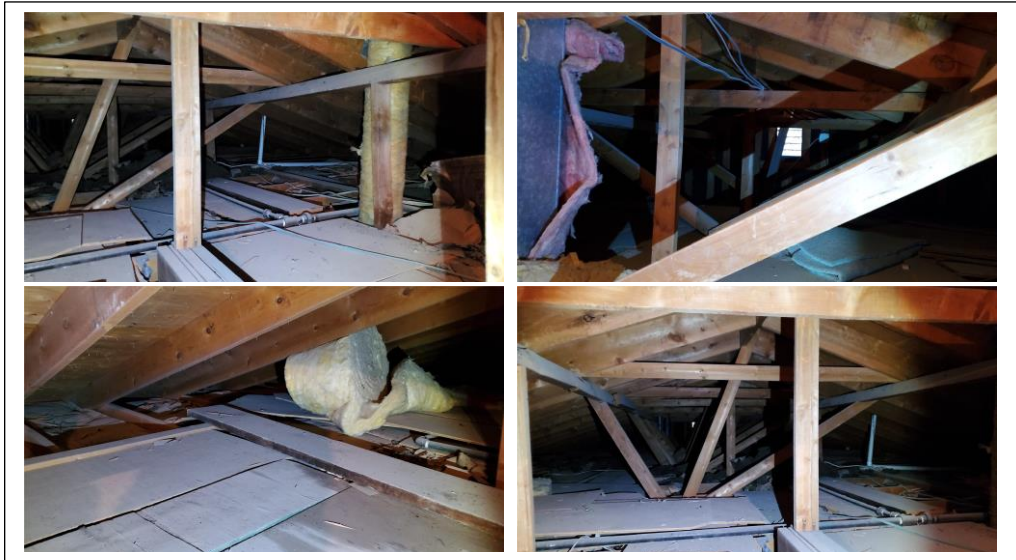
- In my opinion, the **roofing structure** was found to be in good condition on the Date and Time of the Inspection. Therefore, the opinions expressed are one's of apparent conditions and not absolute fact and are only good for the date and time of the inspection.

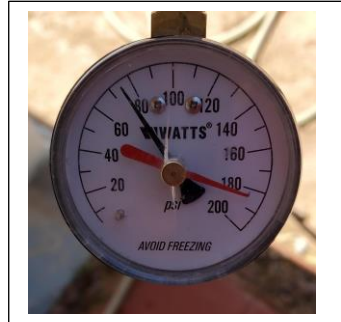
**A.1 EXTERIOR PLUMBING:**

1. One or more of the exterior water hose bibbs {faucets} was not equipped with a back flow and/or anti-siphon {vacuum breaker} device. An anti-siphon device prevents unsanitary water from being pulled back through a garden hose and/or lawn sprinklers and contaminating the household water system.
